Technical Report CERC-95-3
March 1995

Periodic Inspection of Cleveland Harbor East Breakwater, Ohio

Report 1 Base Conditions

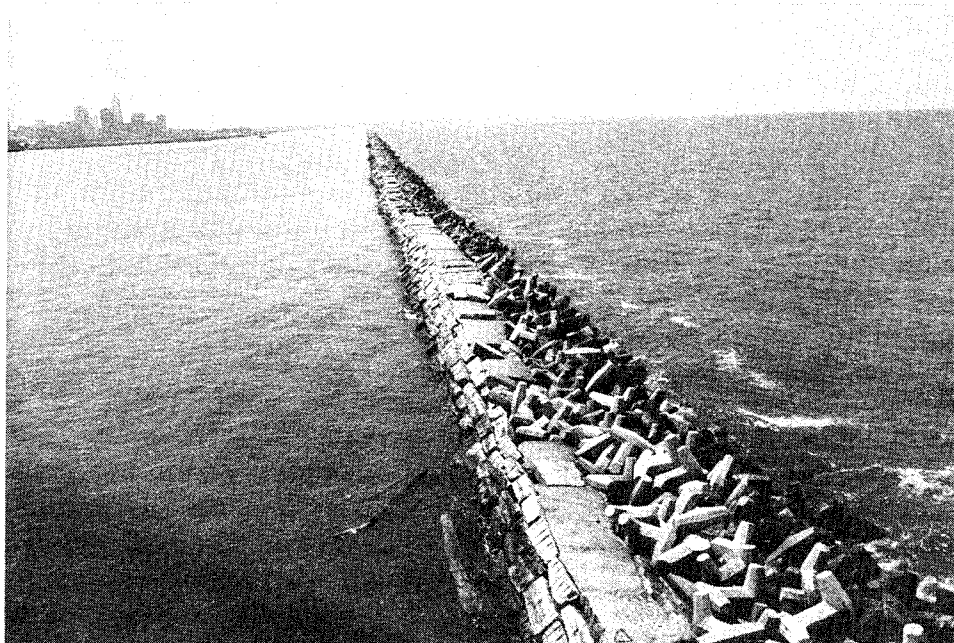
Figure 8. View of dolos-rehabilitated east breakwater trunk (dolosse installed on lakeside of structure)

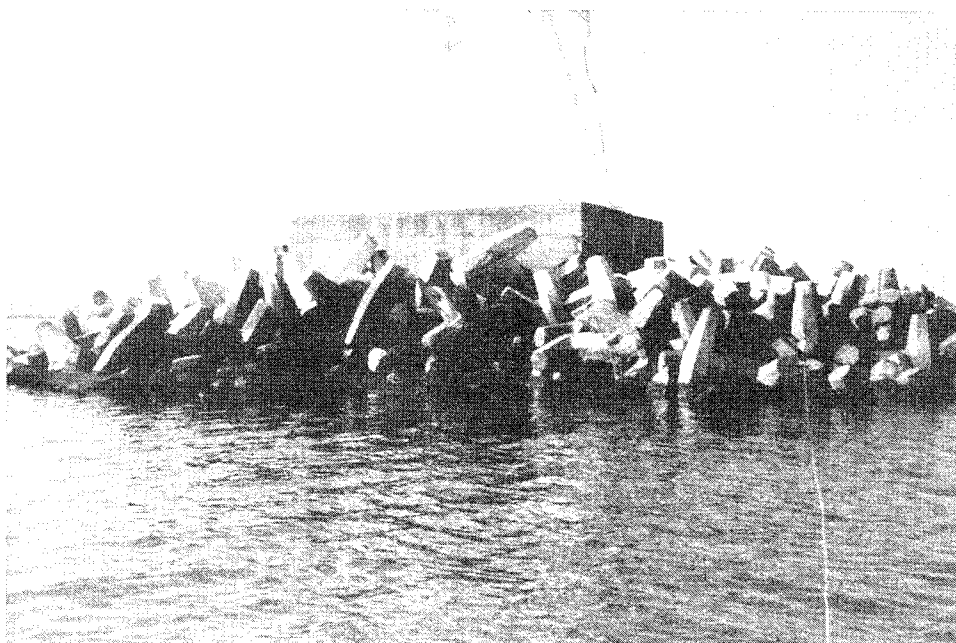
Figure 9. View of dolos-rehabilitated east breakwater head

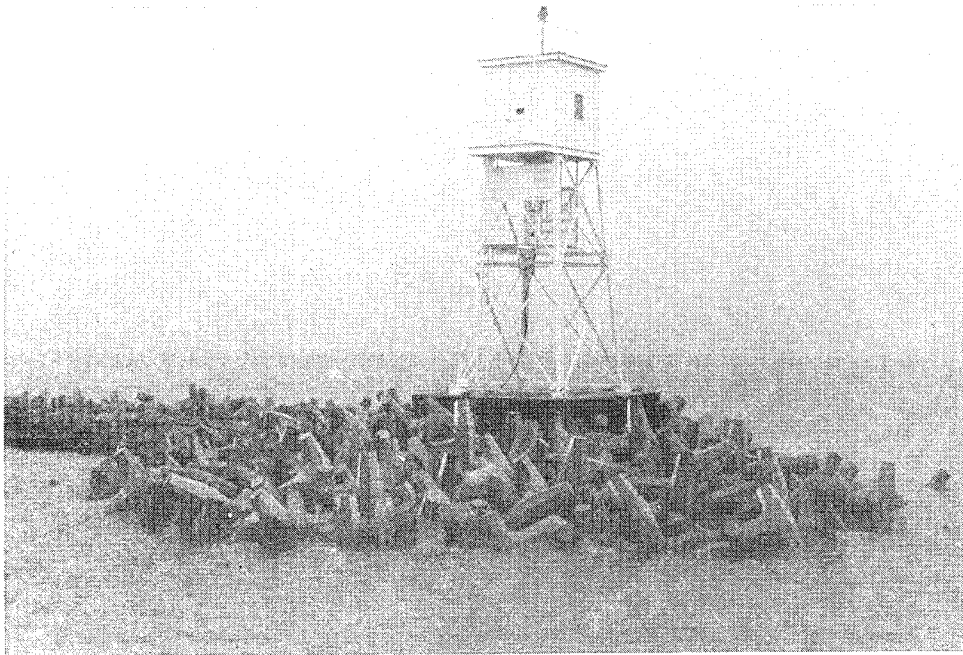
Figure 13. View of 4-ton dolos units placed around head of structure in May 1987

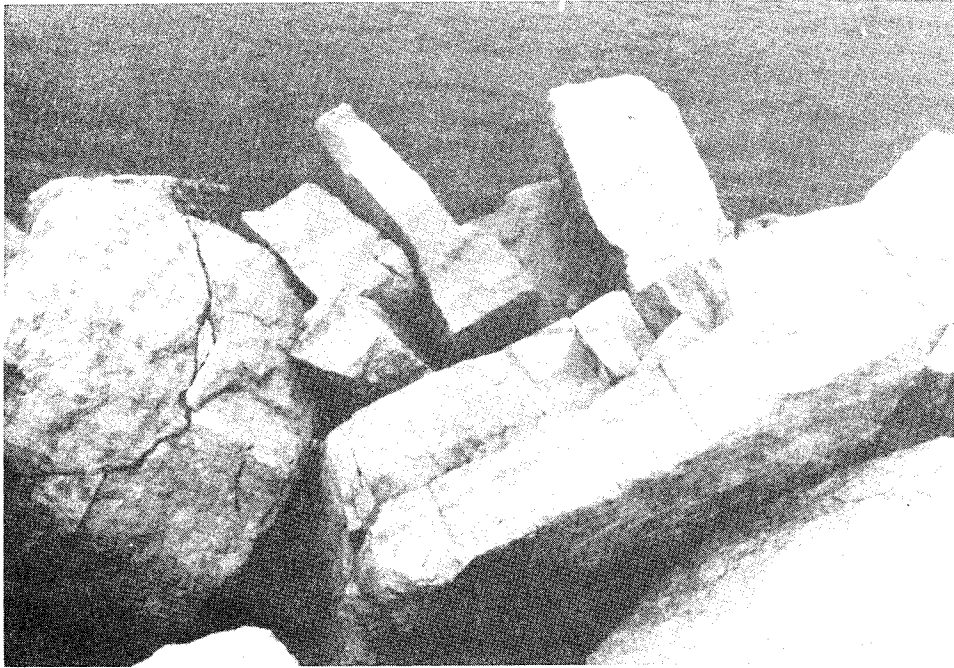
- d. Location of crack, as related to geology (Marcus 1991).
- e. The apparent mechanism for cracking. This is based on stone stress characteristics, man-influenced blast effects (Figure 15) or cracking by natural causes (Figure 16).

Figure 15. Typical man-influenced blast crack damage observed on all study reaches

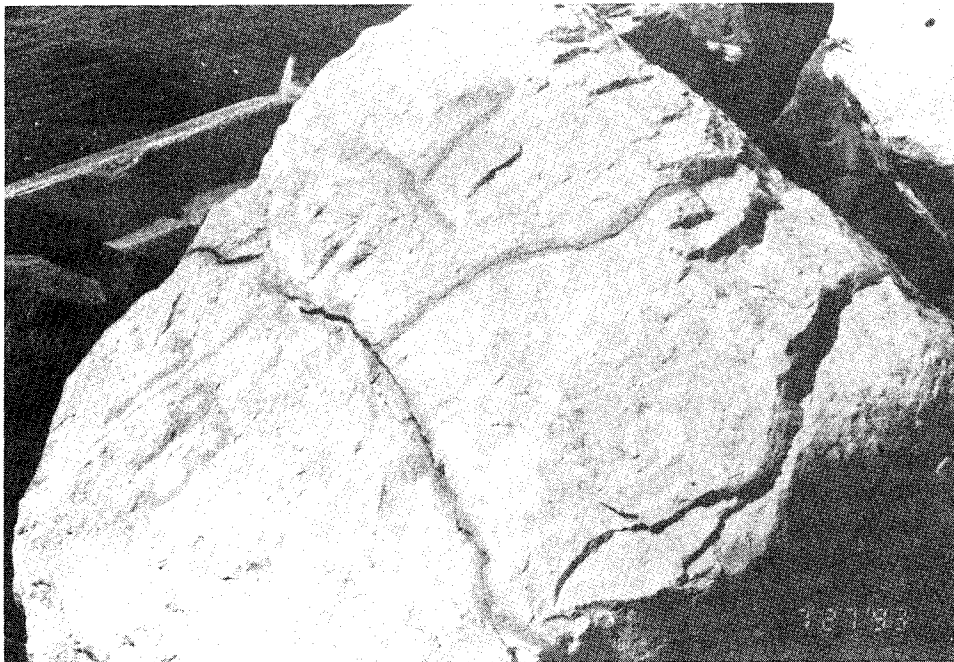
Figure 16. Typical natural mirror image fracturing observed on all study reaches

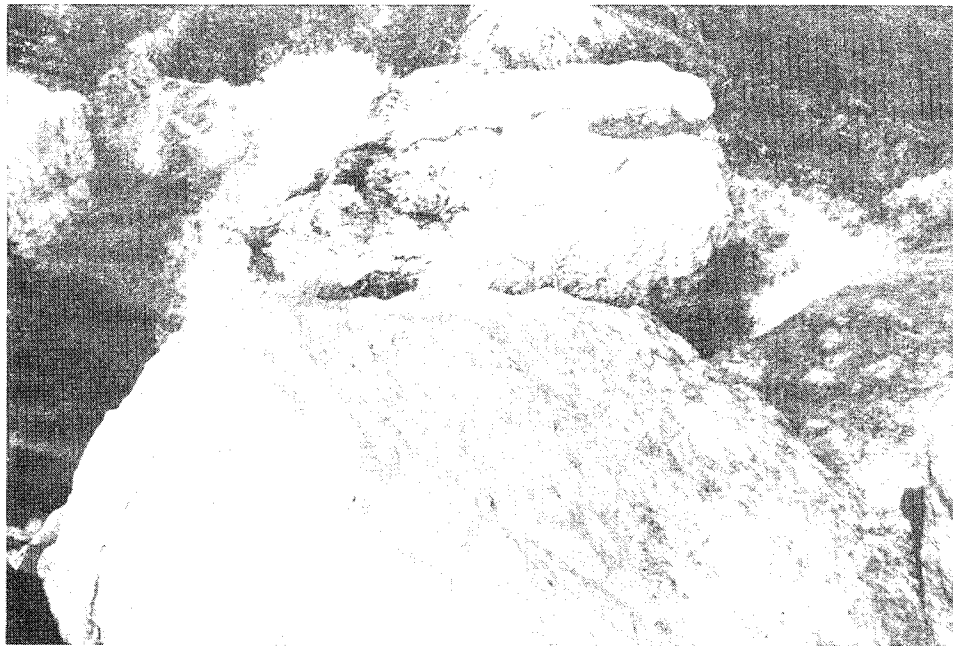
completed in 1992, and the standard Corps QC/QA practice was used. After the first year of exposure, 3 of 54 stones monitored (6 percent) had developed significant cracks. Two of these 3 stones had blast fractured cracks (Figure 20). Documentation of the 54 individual stones was conducted with videotape this season instead of 35-mm photography due to budget constraints.

Figure 20. Blast-fractured stone of study Reach 3 after one exposure season

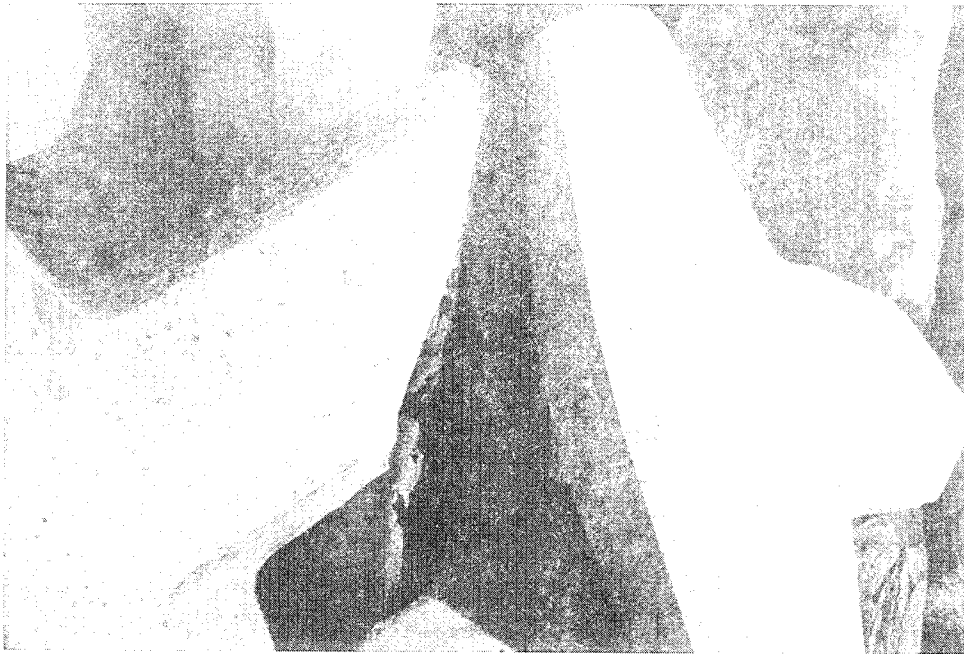
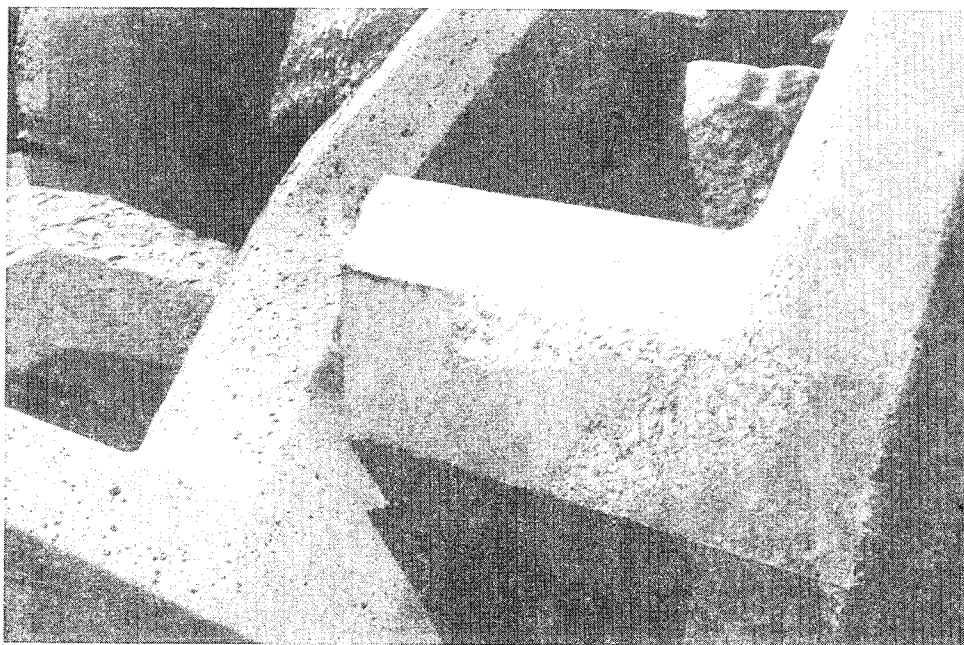
a. Angled mid-shank break

b. Straight mid-shank break

Figure 21. Dolosse with straight and angled mid-shank breaks

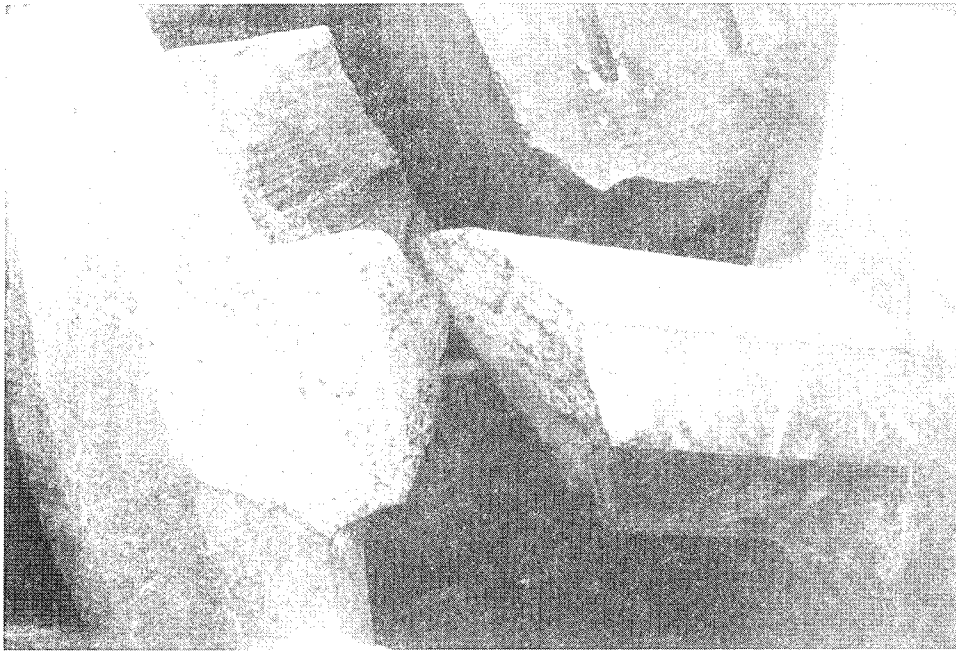
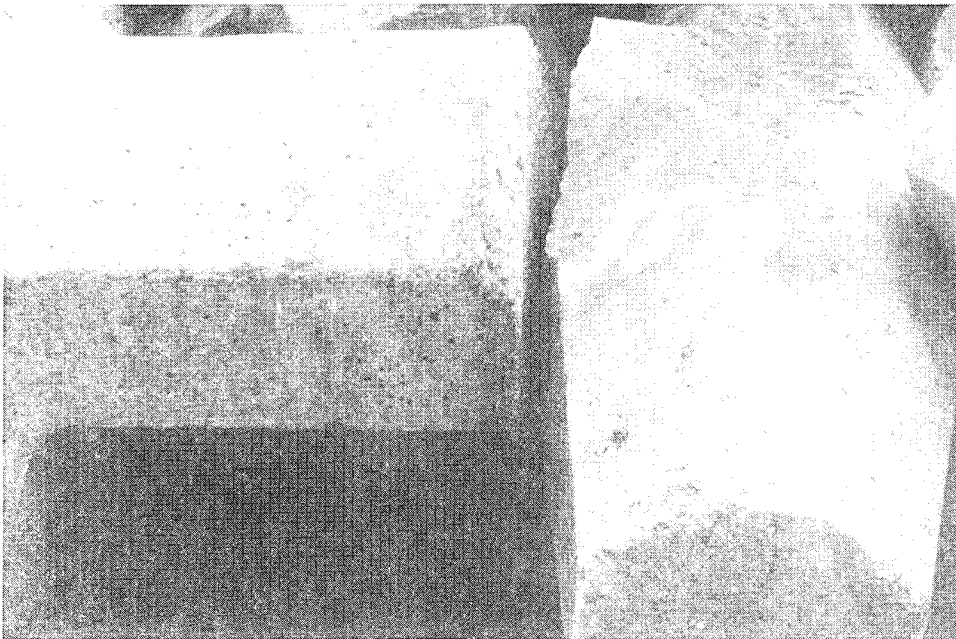
a. Angled shank-fluke break

b. Straight shank-fluke break

Figure 22. Dolosse with straight and angled shank-fluke breaks

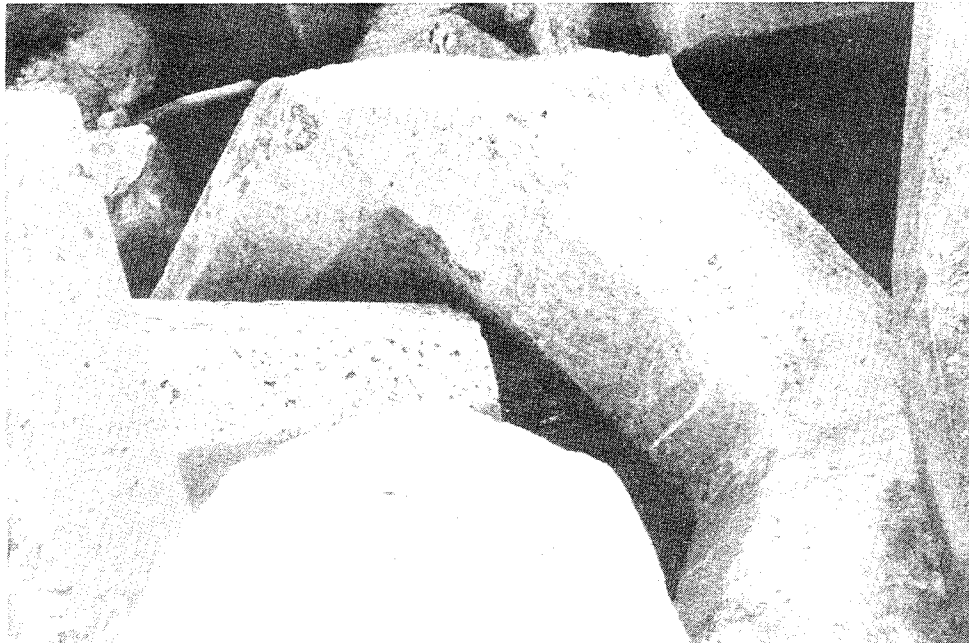
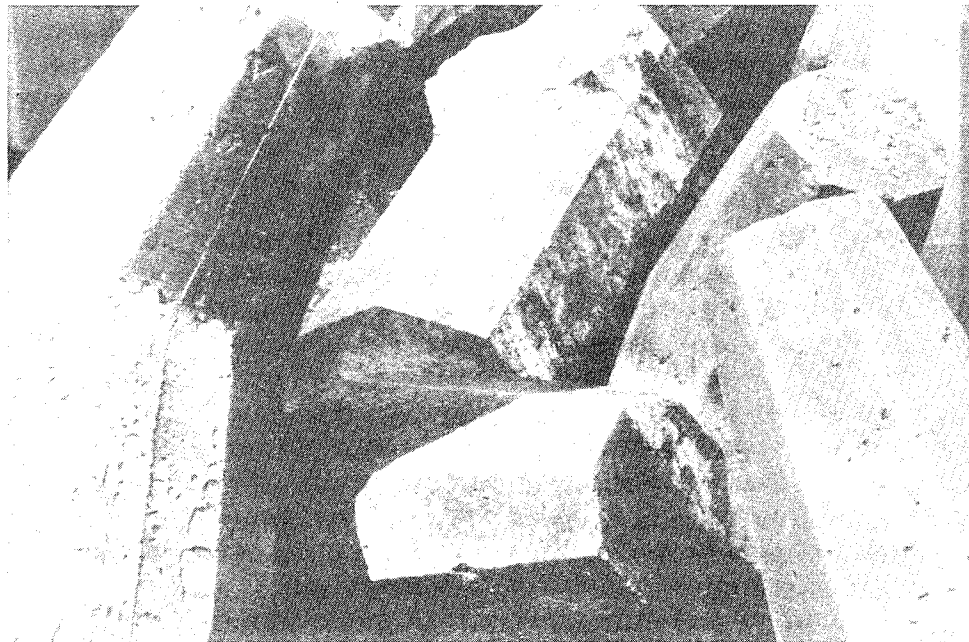
a. Angled fluke-shank break

b. Straight fluke-shank break

Figure 23. Dolosse with straight and angled fluke-shank breaks
